IS/18
dated --.--.2018

Information Message on PRANA Predictive Analytics and Remote Monitoring System

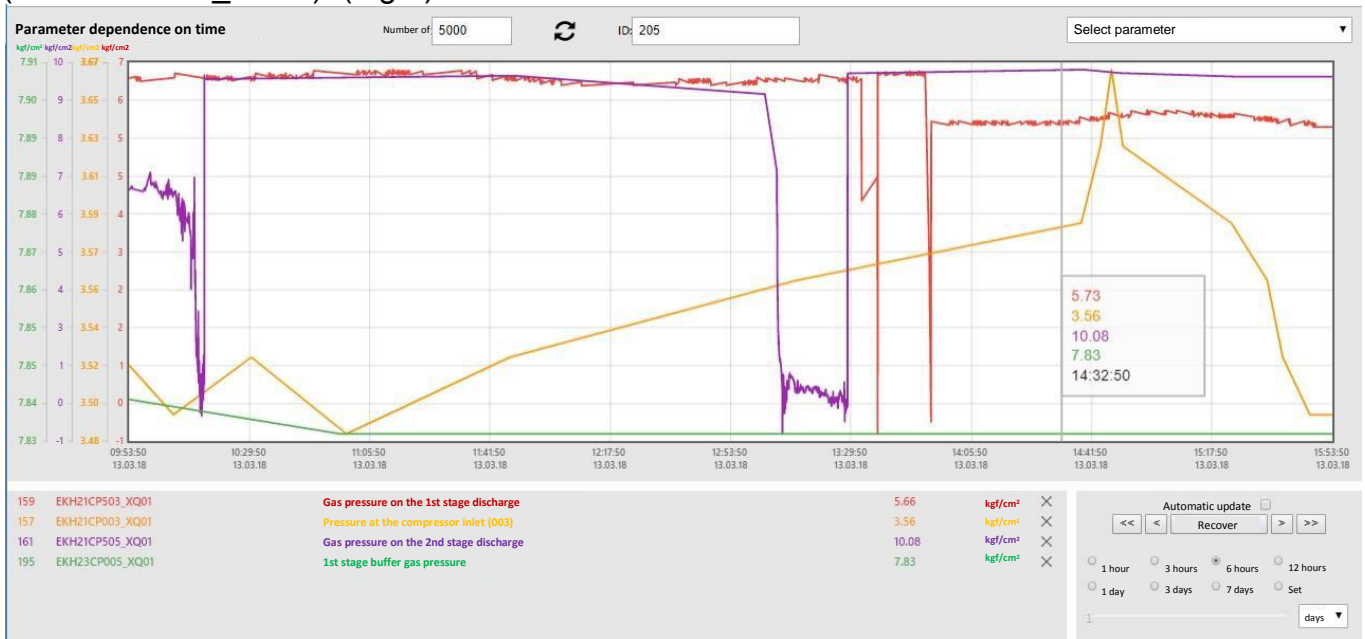
Fig.1 Gas pressure on the 1st stage discharge

On --.--.2018, PRANA predictive analytics and remote monitoring system has detected deviation of GBC technical condition in parameter “Gas pressure on the 1st stage discharge (EKH21CP503_XQ01)” (Fig.1).

From 13:33 to 13:54, pressure changes on the discharge of the compressor 1st stage, uncommon for GBC operation, were observed, which did not correlate to the rest of GBC performance characteristics. After stabilization at 13:54, the pressure value at the 1st stage discharge became lower (about 5.7-5.9 kgf/cm²) than its nominal value of 6.4-6.6 kgf/cm² (according to the Technical Documentation for the Borsig Z.117054 GBC, 1st stage head pressure is about 3.2 bar of 1st stage suction pressure).

Judging by the nature of parameter value change (from 13:33 to 13:54), the probable cause of the deviation occurred is a procedure of pressure sensor check by pulse line purging, or pressure sensor failure.

1. Purge the pulse lines of gas pressure sensor on the compressor 1st stage discharge (EKH21CP503_XQ01).
2. Restore the performance ability of gas pressure sensor on the compressor 1st stage discharge (EKH21CP503_XQ01).
3. In order to improve the quality of recommendations, please provide feedback.
