IS/18
dated --.--.2018

Information Message on PRANA Predictive Analytics and Remote Monitoring System

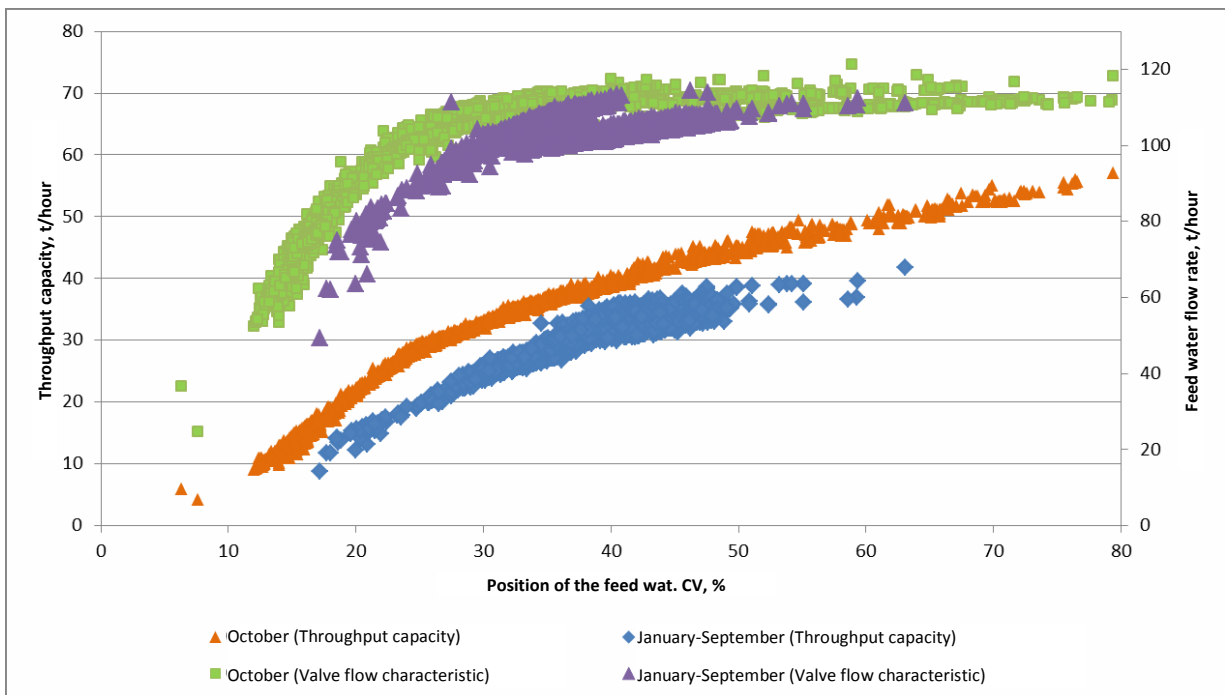
Observed change in the control valve throughput capacity (Fig. 1). This leads to the deterioration in the quality of level control in the drum.

The probable causes of detected deviation are:

1. Mechanical damages to HPT feed control valve.
2. PEN-1A (01LAC22CP001XJ116) head pressure drop due to the increase in the throughput of PEN-1A automatic spill-back valve.

Fig. 1. Throughput capacity and flow characteristics of the feed water CV

1. Compare position at control valve location against the readings at control board WKS.
2. During the next planned shutdown, inspect the feed control valve in order to identify the causes of changes in throughput capacity.
3. During the next planned shutdown, inspect PEN - 1A automatic spill-back valve.
4. In order to improve the quality of recommendations, please provide feedback.
