IS/18
dated --.--.2018

Information Message on Remote Monitoring and Predictive Analytics System

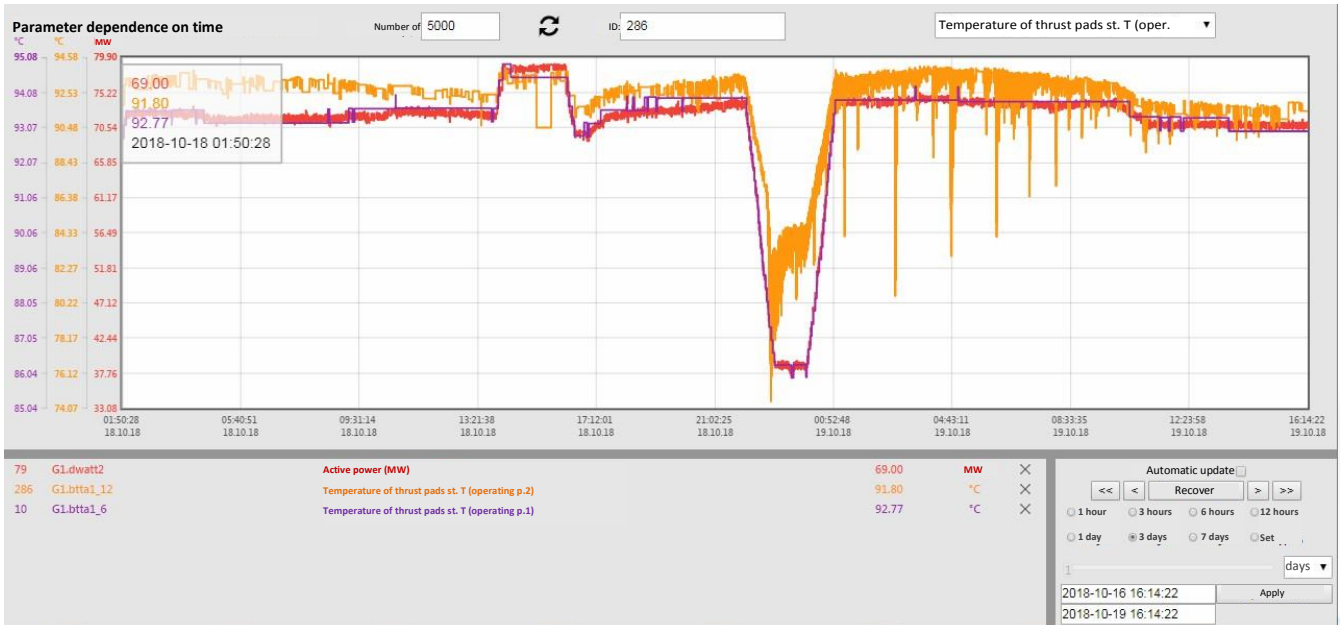
On --.--.2018, remote monitoring and predictive analytics system detected deviation of GT-1 technical condition in G1.btta1_12 parameter “Thrust pads temperature (oper. p.2)” (Fig. 1).

Fig. 1 Temperature of GT-1 thrust pads (oper. p.1 and p.2)

Changes in readings have a wide spread of values, are of jump-like nature and do not correlate to the rest of thrust pad temperature readings (oper. p.1).

1. Check communication lines from the sensor to the I/O modules.
2. Pull the terminal connections of G1.btta1_12 sensor.
3. Calibrate the measurement channel.
4. Check the performance ability of G1.btta1_12 sensor.
5. In case the temperature readings remain unstable after the measures performed, as per para. 1-2, replace G1.btta1_12 resistance thermometer during the next GTU shutdown.
6. In order to improve the quality of recommendations, please provide feedback.
