IS/18
dated --.--.2018

Information Message on PRANA Predictive Analytics and Remote Monitoring System

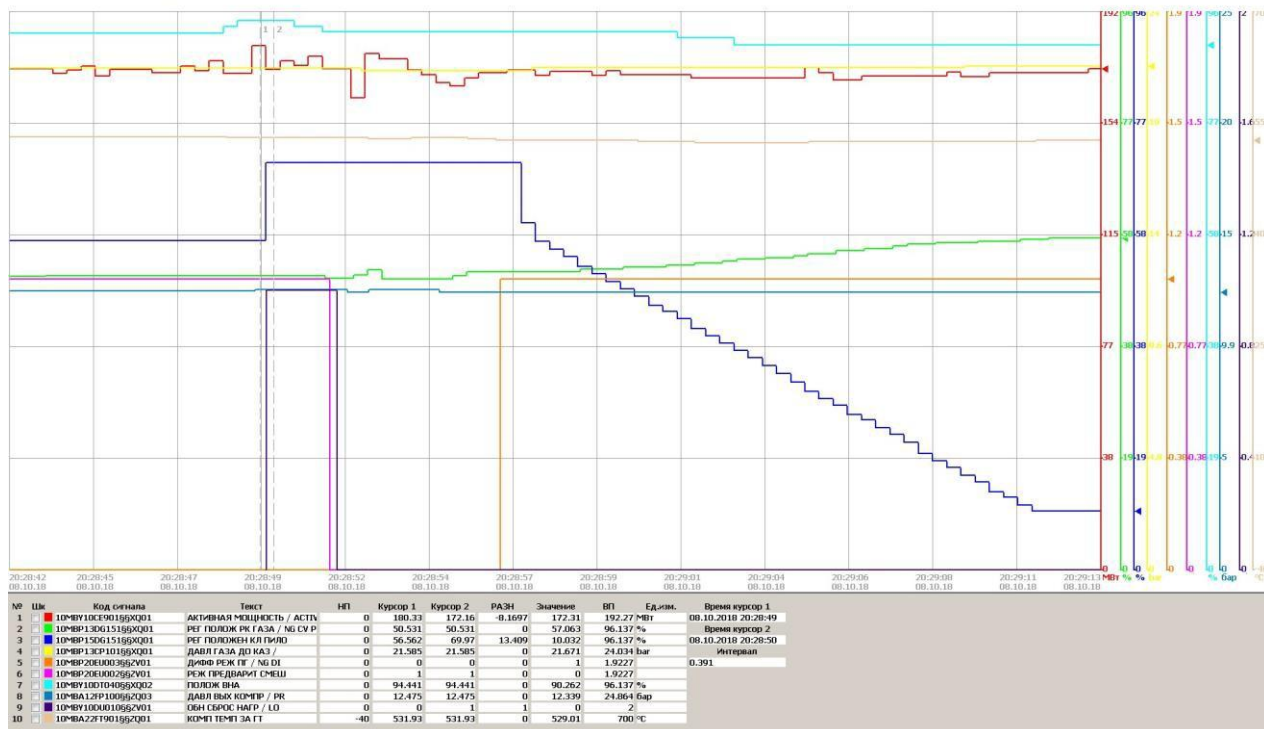
Fig. 1 Switching to diffusion on 08.09.2018

On --.--. 2018 at 20:29, the PRANA predictive analytics and remote monitoring system revealed a change in the technical condition of GTU, associated with the transition from pre-blend to diffusion mode at the load of 171 MW and the corrected temperature at the GT exhaust of 531 °C.

- On --.--.2018 at 20:28:50, a quick (abnormal) transition from pre-mixing to diffusion was automatically performed due to load shedding (Fig. 1).
- During the analysis of the Event Log, periodic signal passages were also detected (see Fig. 2, marked by hatching):

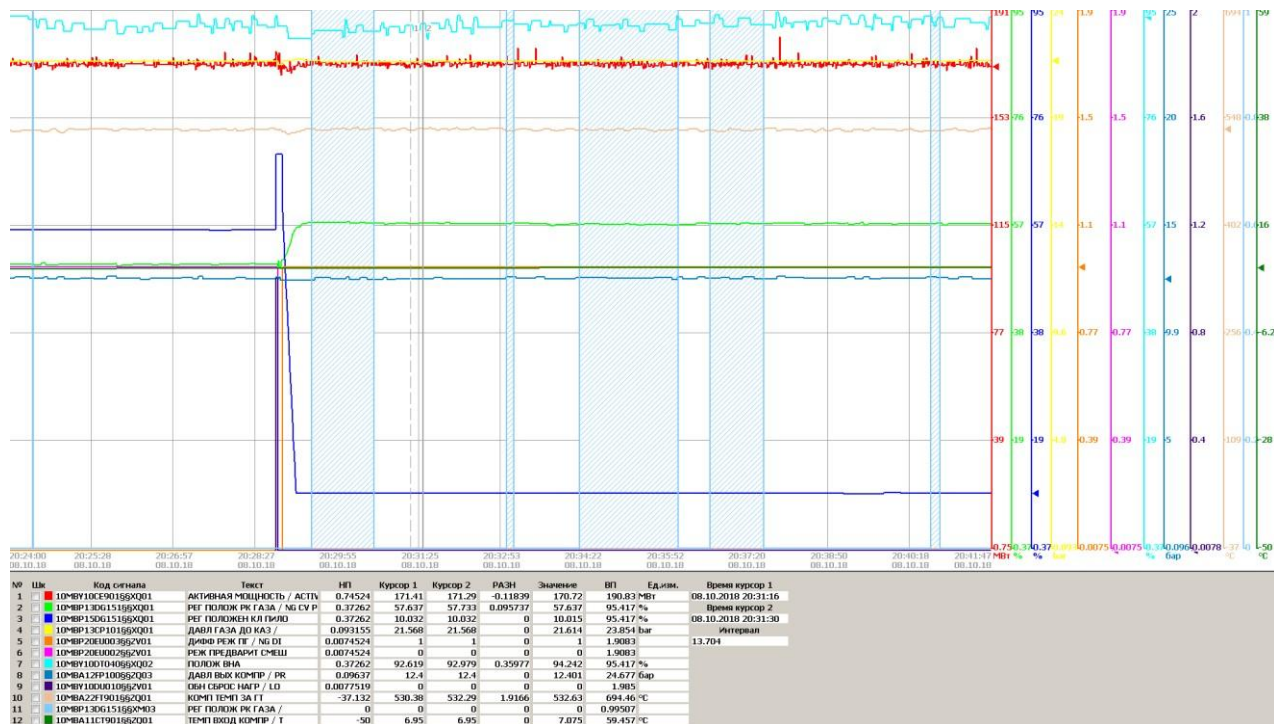
Fig. 2. 10MBP13DG151||XM03 signal passage on --.---.2018

10MBP13DG151|XM03 NG CV POSN CTRL OPER POINT

Passage of this signal indicates that an absolute value at the position controller output for a natural gas master valve (11MBP13AA151) exceeds the specified upper limit.

- Impact is made on the proper functioning of position control of natural gas master valve (11MBP13AA151);
- The control valve actuator should be checked and reset with the next turbine downtime.

Thus, the improper functioning of the natural gas master valve can lead to the malfunctions in gas distribution system and deviations in the combustion mode.

1. Check the valve for mechanical and/or electrical damage, check the valve stroke with a comparison of the position in place against the readings at operator workstation.
2. Check the servo driven coils for wire breaks.
3. Check the servo valve for wear (flexible hose, pullback spring, control piston, etc.).
4. Check hydraulic oil characteristics (temperature, viscosity, moisture absorption).
5. Adjustment point should be checked and, if necessary, set to a reference value by the ACS technician. If deviation is > 5%, contact the service company or the equipment manufacturer.
