IS/18 dated --.-.2018

Information Message on PRANA Predictive Analytics and Remote Monitoring System

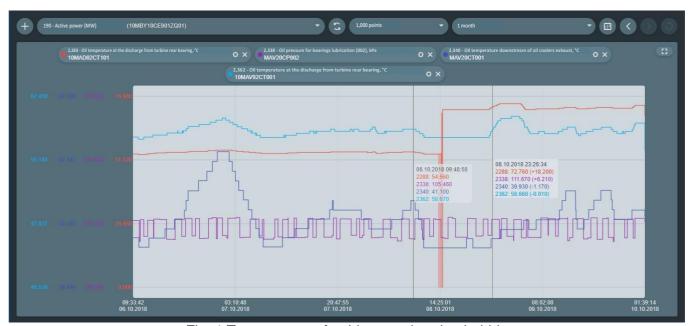
PRANA Predictive Analytics and Remote Monitoring System detected deviation of steam turbine technical condition in the parameter "Temperature of turbine rear bearing babbit" (10MAD02CT101) (Fig. 1).

Fig. 1 Temperature of turbine rear bearing babbit.

On --.--.2018, changes in the temperature of turbine rear bearing babbit (10MAD02CT101) uncommon for steam turbine operation were observed, which did not correlate to the rest of steam turbine operation parameters. On --.--.2018, the dispatcher of the Situational Center notified site personnel about the deviation in parameter readings and, as a feedback, received a response about the repair activities on the specified sensor.

After the failure of control instrumentation and subsequent stabilization of the readings, the temperature of turbine rear bearing babbit reached more than 70 °C. According to process signaling chart, pre-alarm value is 70 °C; till now, the parameter exceeds the setpoint value.

- 1. Check communication lines from the sensor to the software/hardware modules.
- 2. Pull clamp connections of communicating line of the sensor.
- 3. Check the temperature sensor operability (according to the calibration chart).
- 4. Calibrate temperature measurement channel.
- 5. Report on actions taken to the Situational Center.

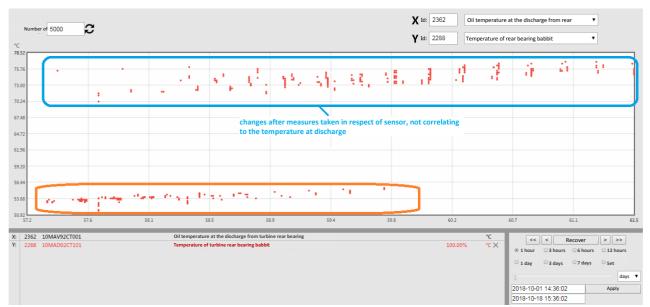
By the nature of the parameter change, probable cause of the deviation occurred may be an increased measuring channel error (Fig. 2).

Fig. 2. Temperature of turbine rear bearing babbit and oil temperature at discharge.
