Date : 21.12.2018
Company :
Branch :
Plant :
Unit : GTE-160 st. No. 2
Factory No:

Conclusion No. 02.1-R

On the impact of repairs / adjustment works on the technical condition of the unit

Date of shutdown for repairs	Repair / adjustment finish date	Repair duration, days	Reason for repairs
15.09.2018	24.10.2018	39	Conduct of a large scheduled inspection of GT after 33,000 equivalent hours of operation.

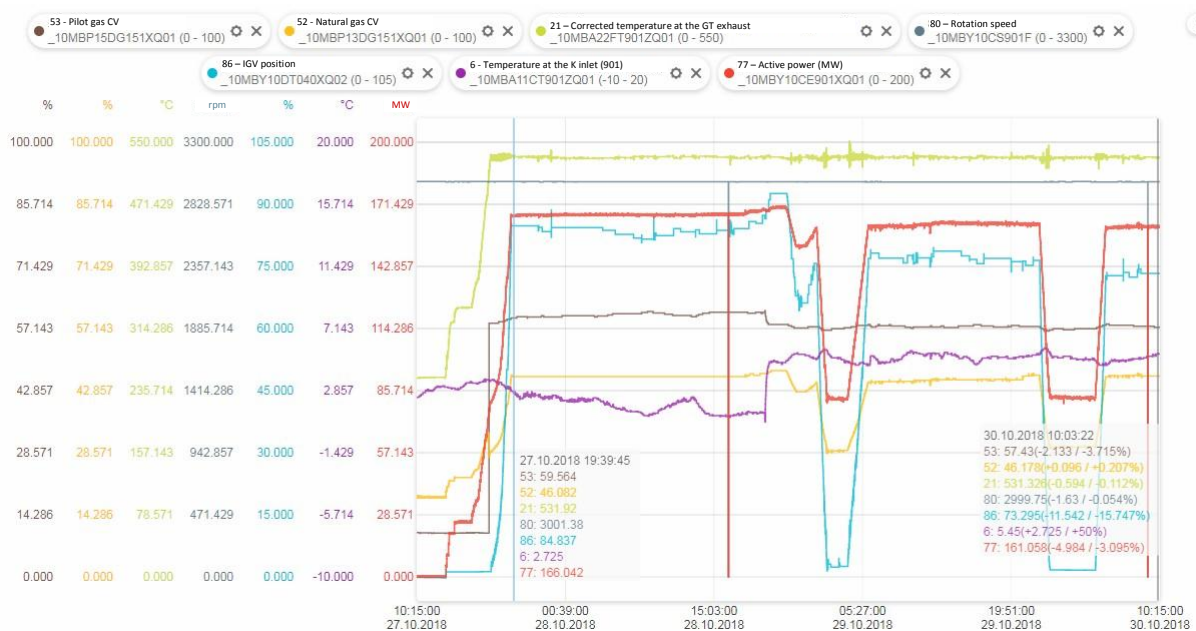
Fig.1 GTU indicators after repairs (within 72 hours).

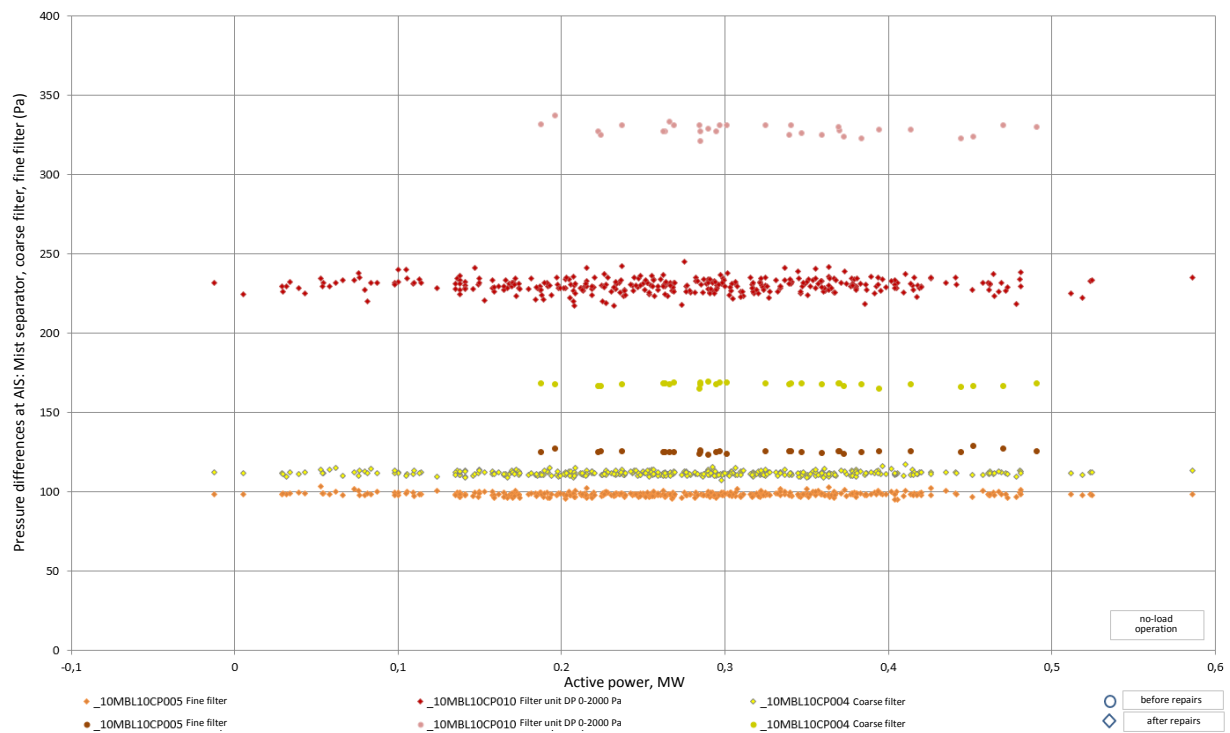
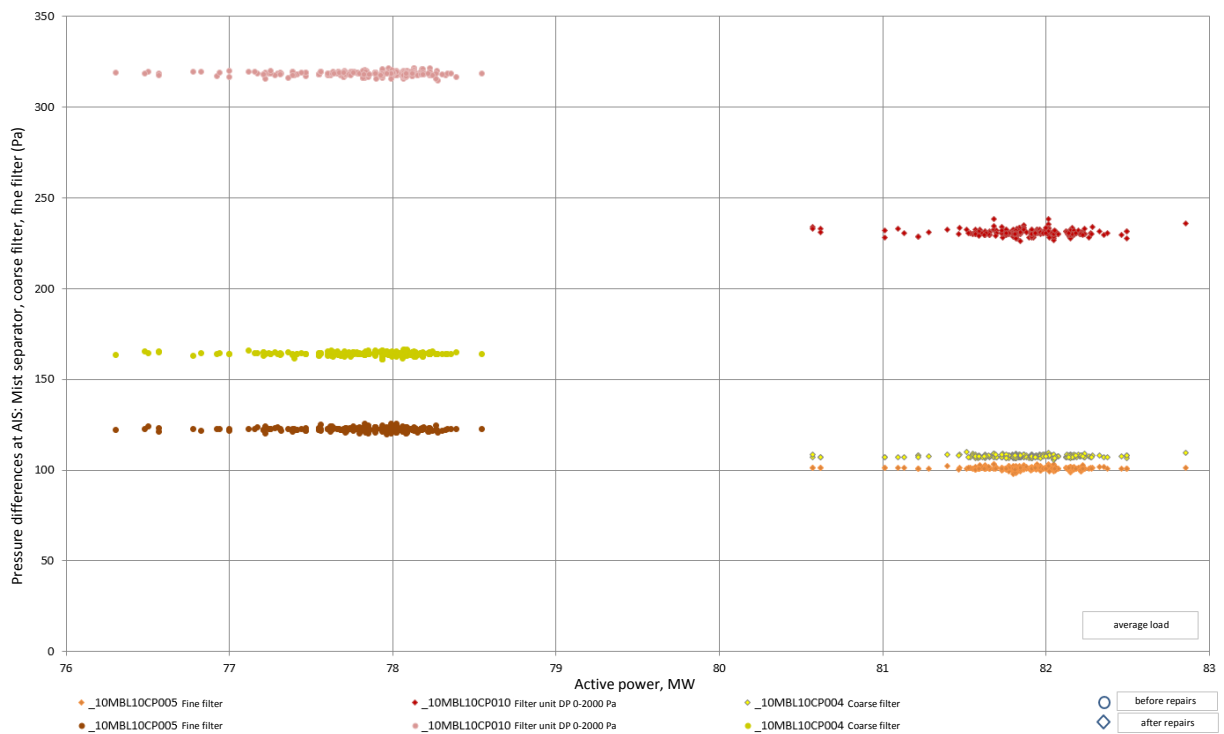
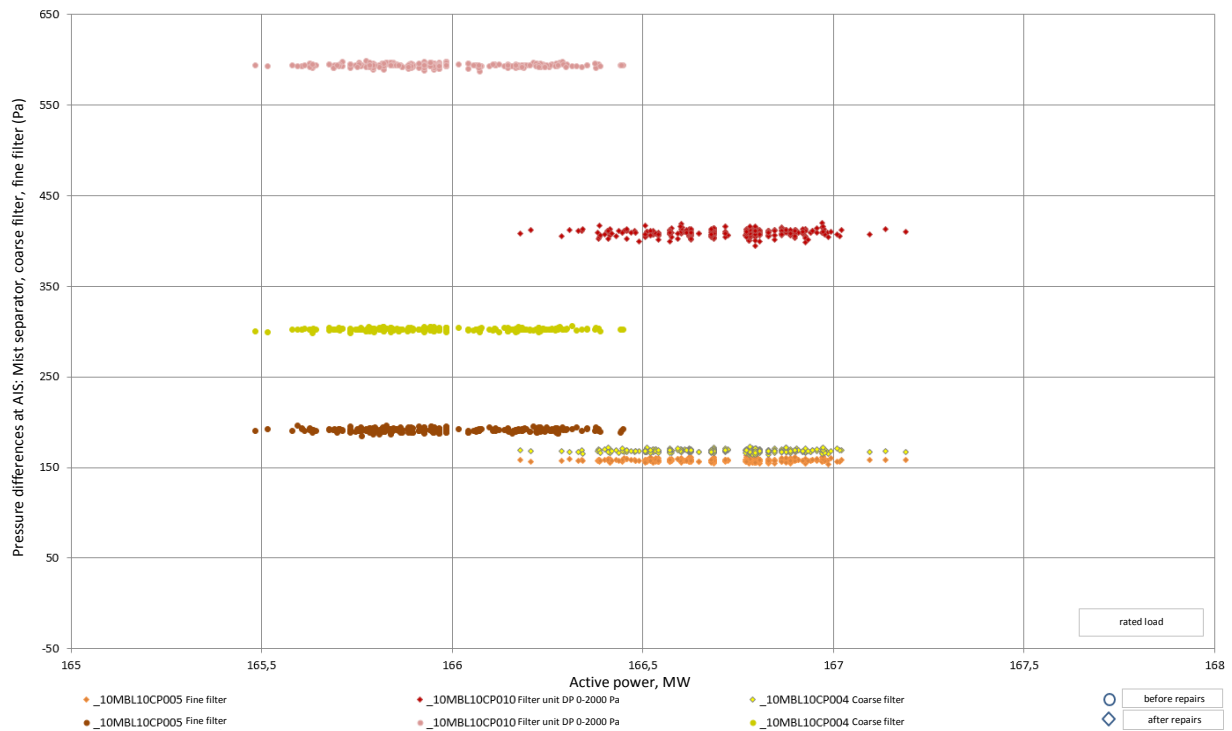
Parameters deviations: In line with performed operations.
Changes in pressure difference at AIS sections are associated with the replacement of filter element during large inspection.
Changes in pressure at the outlet of the compressor and compressor pressure ratio respectively, can be associated with control instrumentation calibration. Deviations in temperature at the GT (108B) exhaust are associated with a malfunction of thermocouple / contact weakening during start-up.

3. *A positive effect of reduced resistance in the air duct is registered due to the replacement of AIS filter element and compressor blades cleaning.*

Fig. 1.1. AIS parameters, no-load operation before/after repairs

Fig. 1.2. AIS parameters, average load mode before/after repairs

Fig.1.3. AIS parameters, nominal load mode before/after repairs

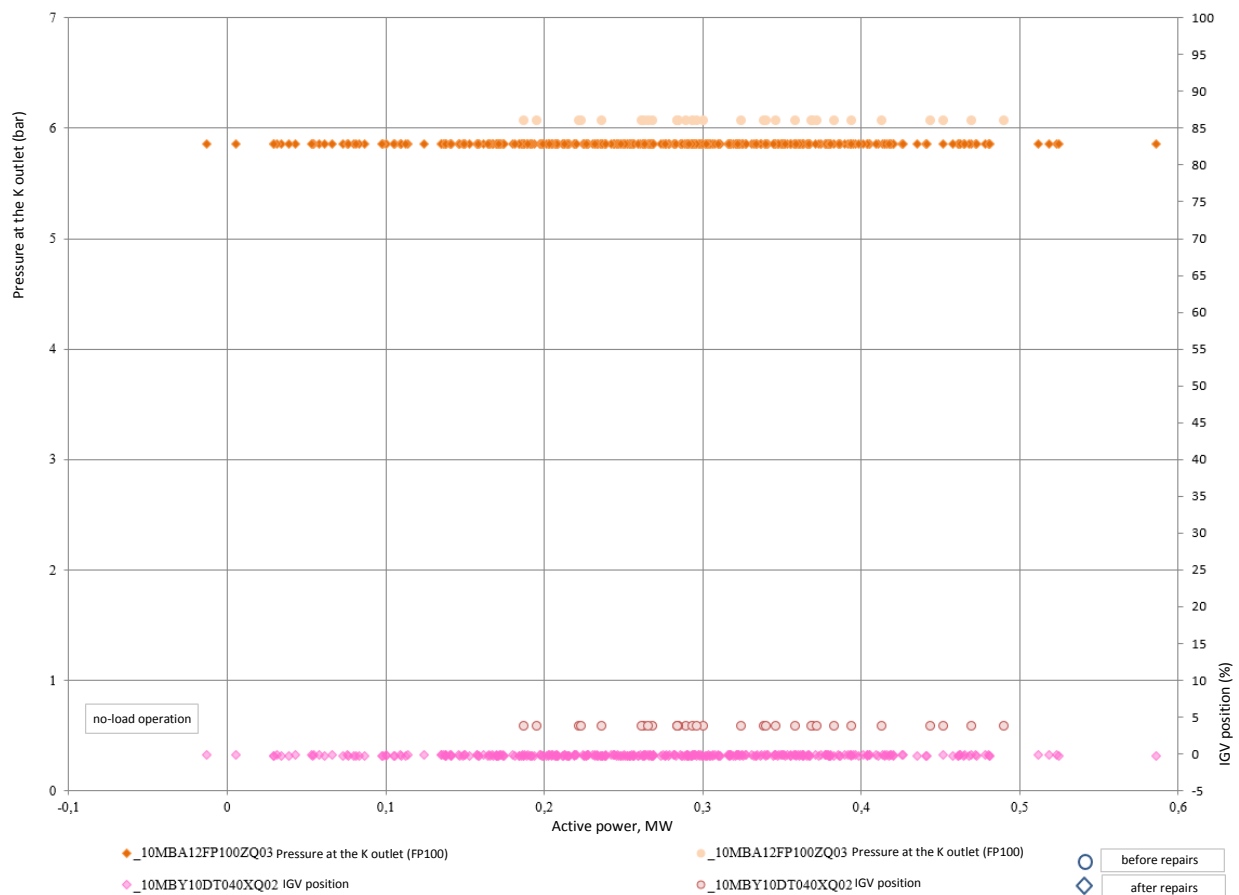
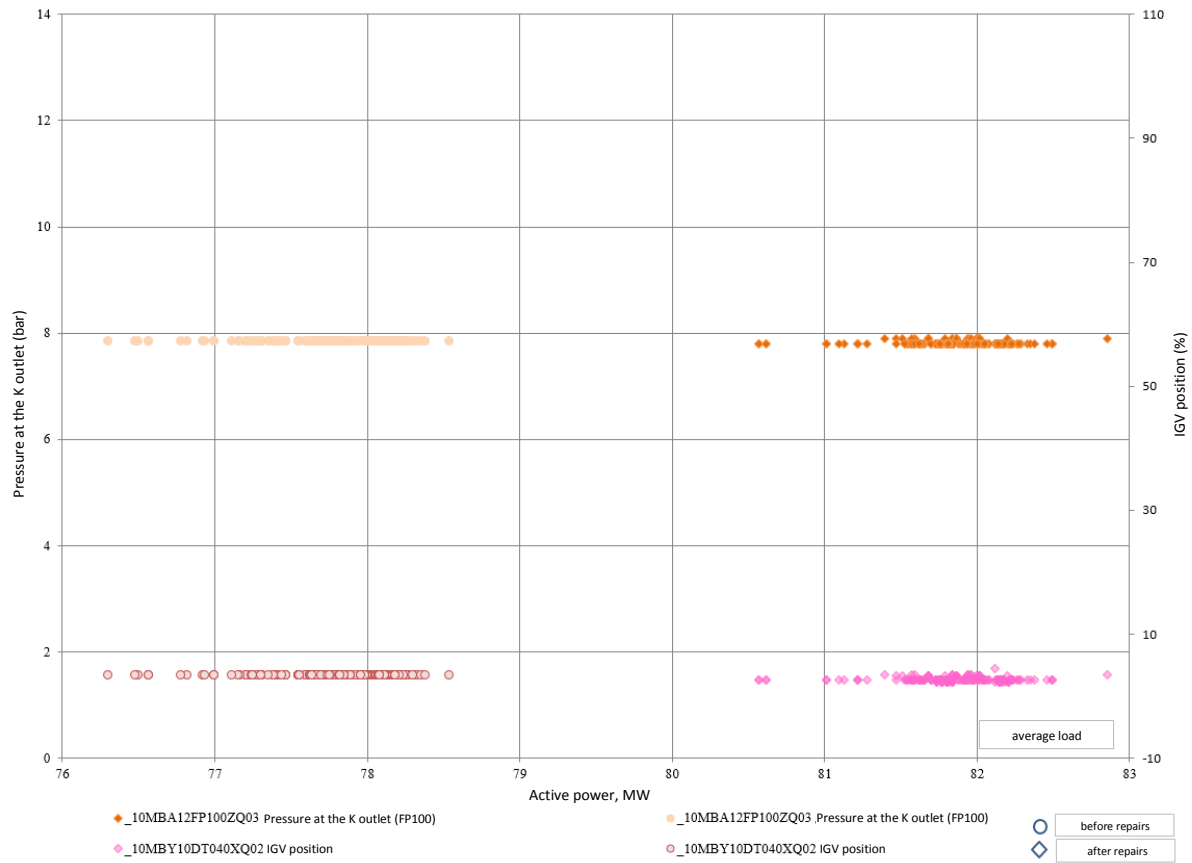
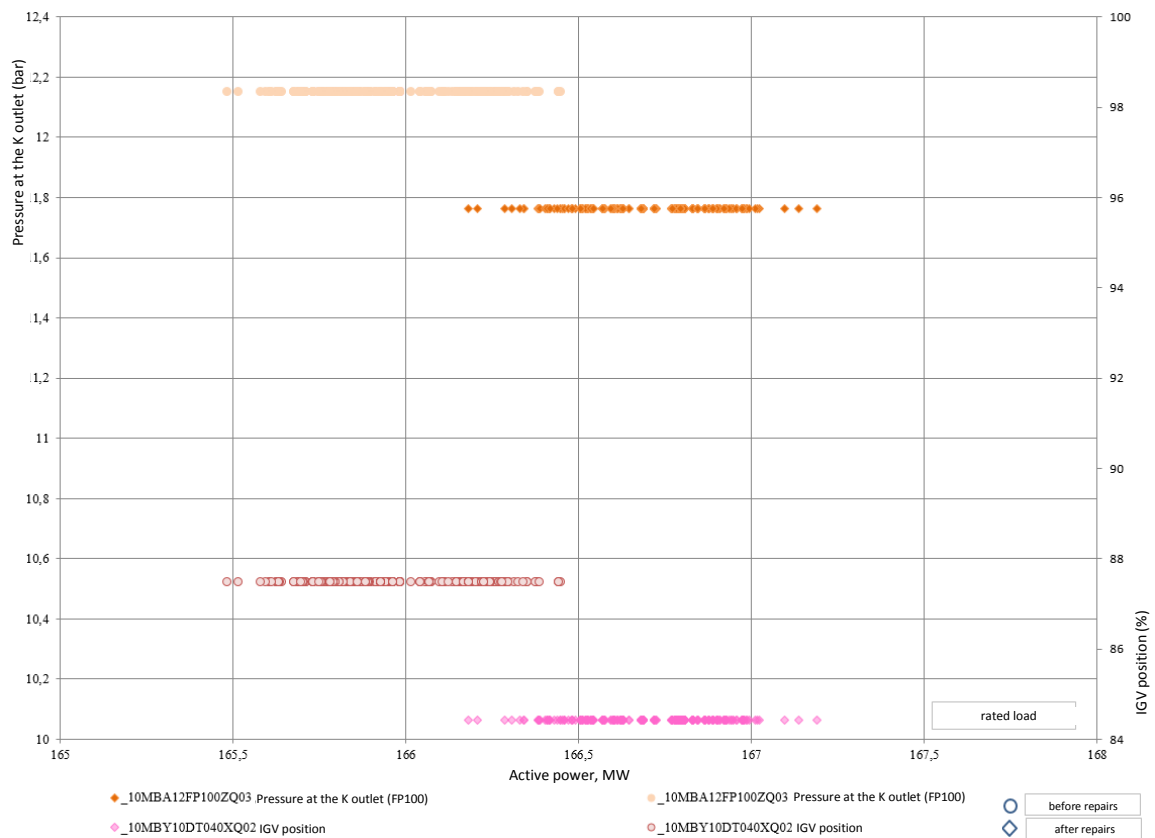
Fig. 2.1. Pressure at the compressor outlet, no-load operation before/after repairs

Fig. 2.2. Pressure at the compressor outlet, average load mode before/after repairs

Fig. 2.3. Pressure at the compressor outlet, nominal load mode before/after repairs

4. *Changes in pressure at the outlet of compressor (and compressor pressure ratio respectively) can be associated with control instrumentation calibration and with IGV settings adjustment (if performed). Taking into account the positive effect of reducing resistance in the air duct, it is recommended to re-calibrate pressure sensor at the outlet of compressor, check whether changes have been made to IGV setting at ultimate opening angles.*

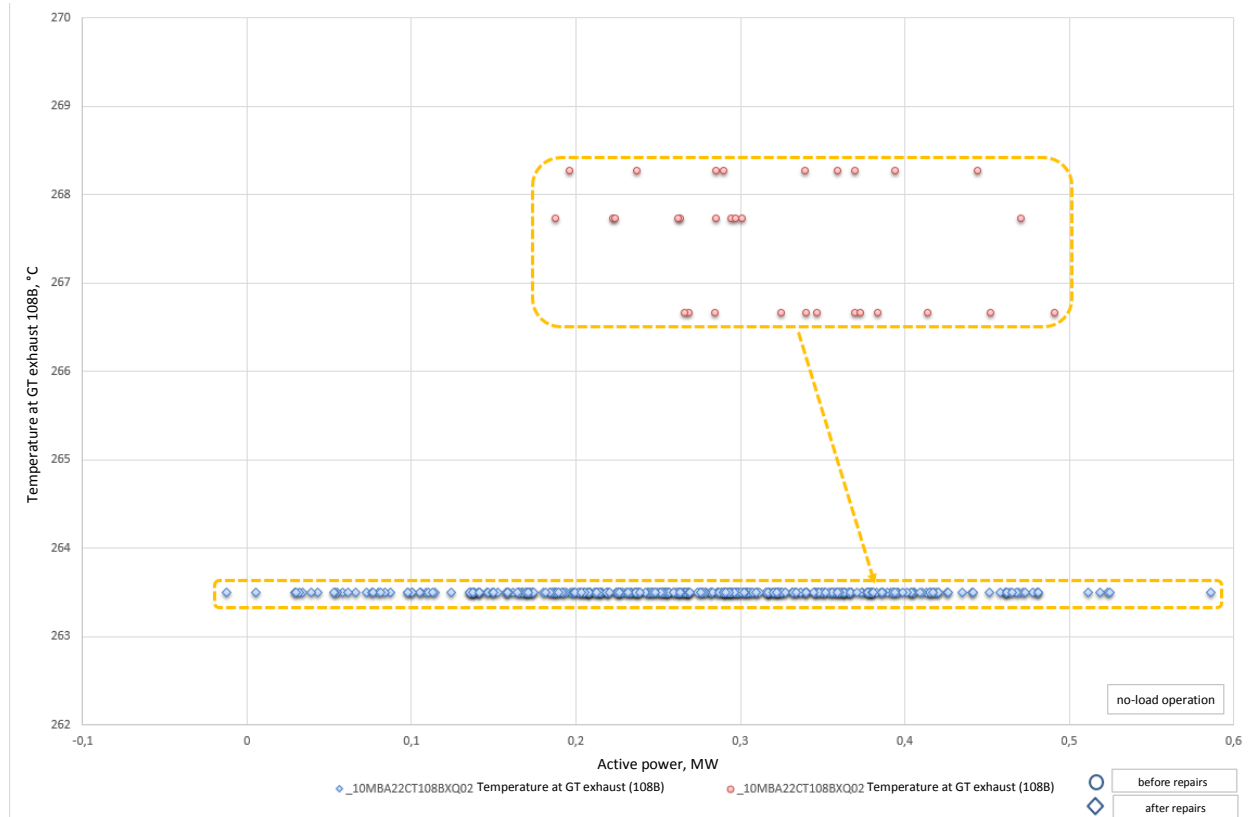
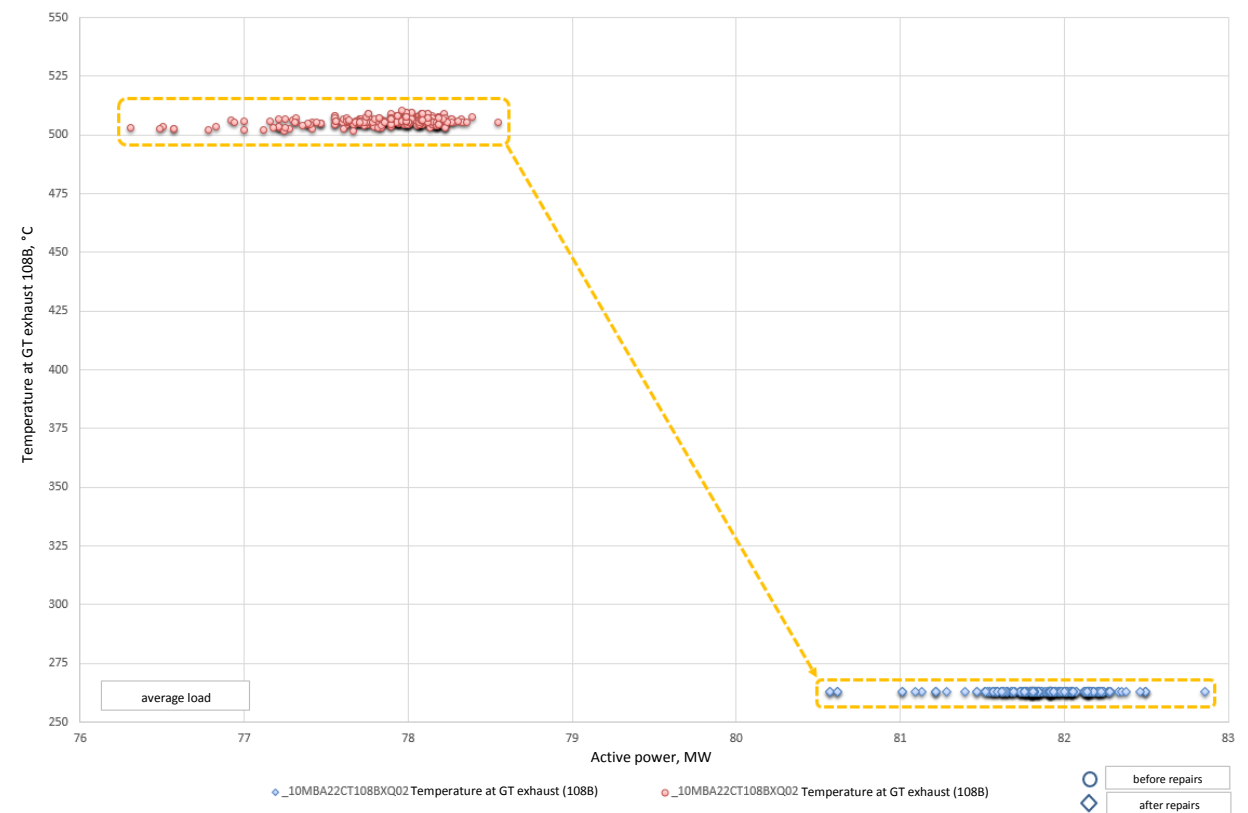
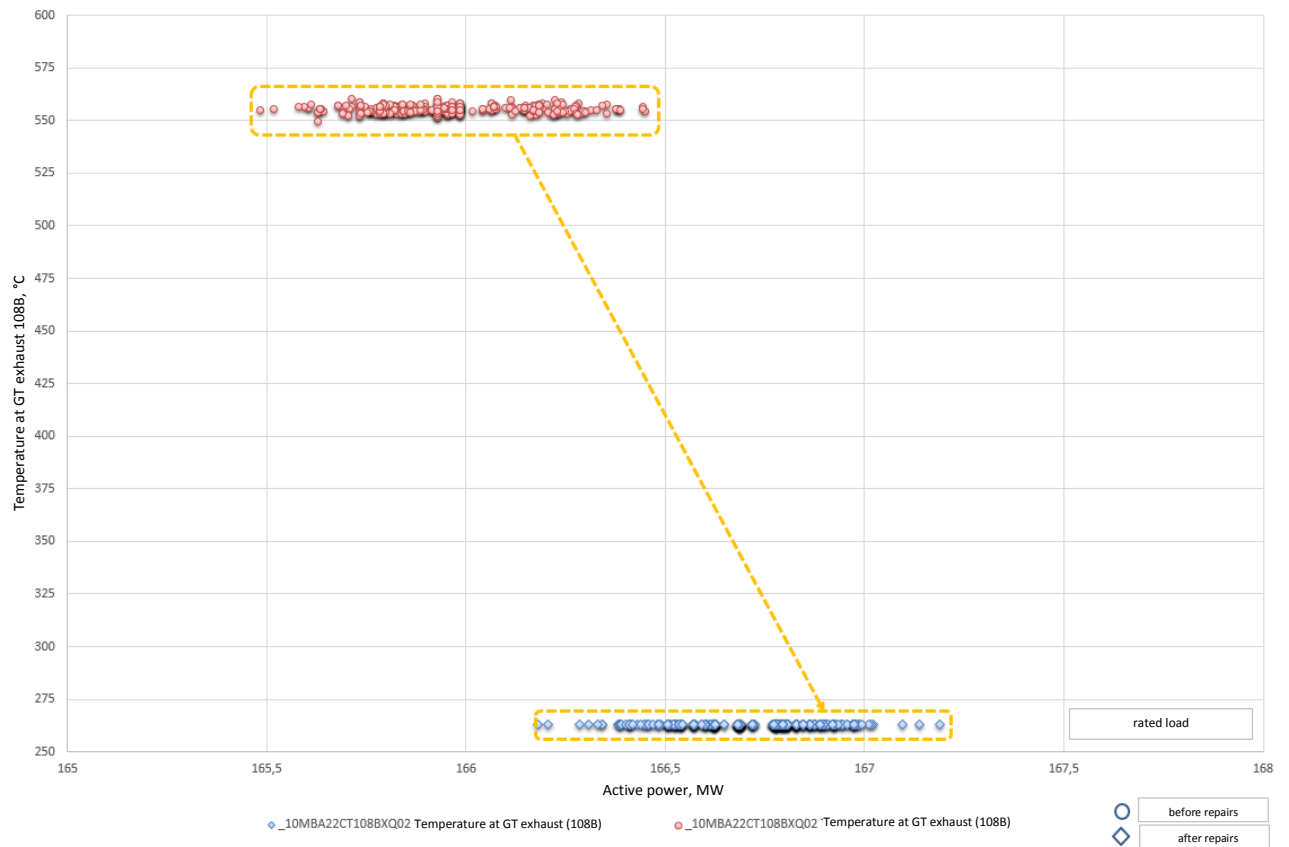
5. *Detected deviations in the parameter “Temperature at GT exhaust (108B)” 10MBA22CT108BXQ02 during the start-up after repairs are caused by the thermocouple measurement channel malfunction or by poor contact.*

Fig.3.1. Temperature at GT exhaust 108B, no-load operation before/after repairs

Fig. 3.2. Temperature at GT exhaust 108B, average load mode before/after repairs

Fig. 3.3. Temperature at GT exhaust 108B, nominal load mode before/after repairs

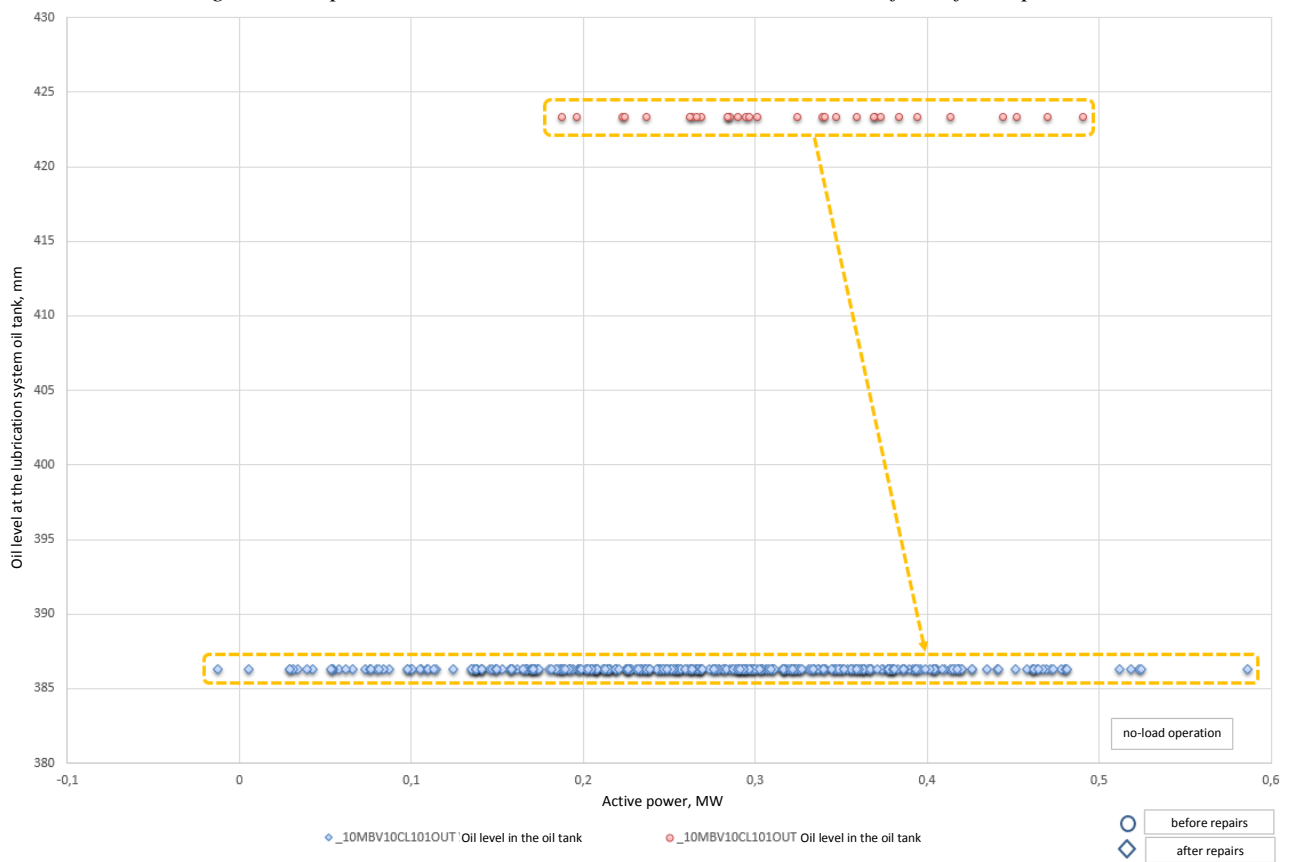
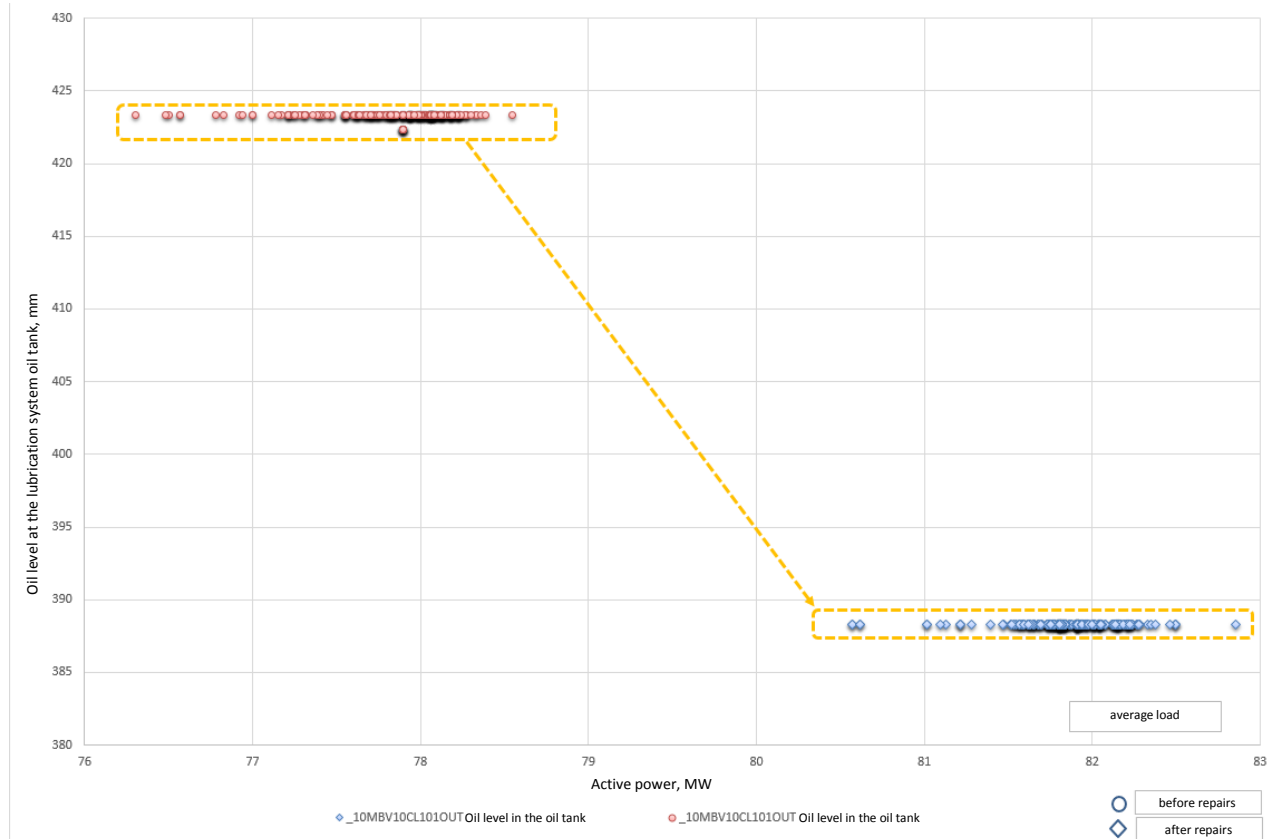
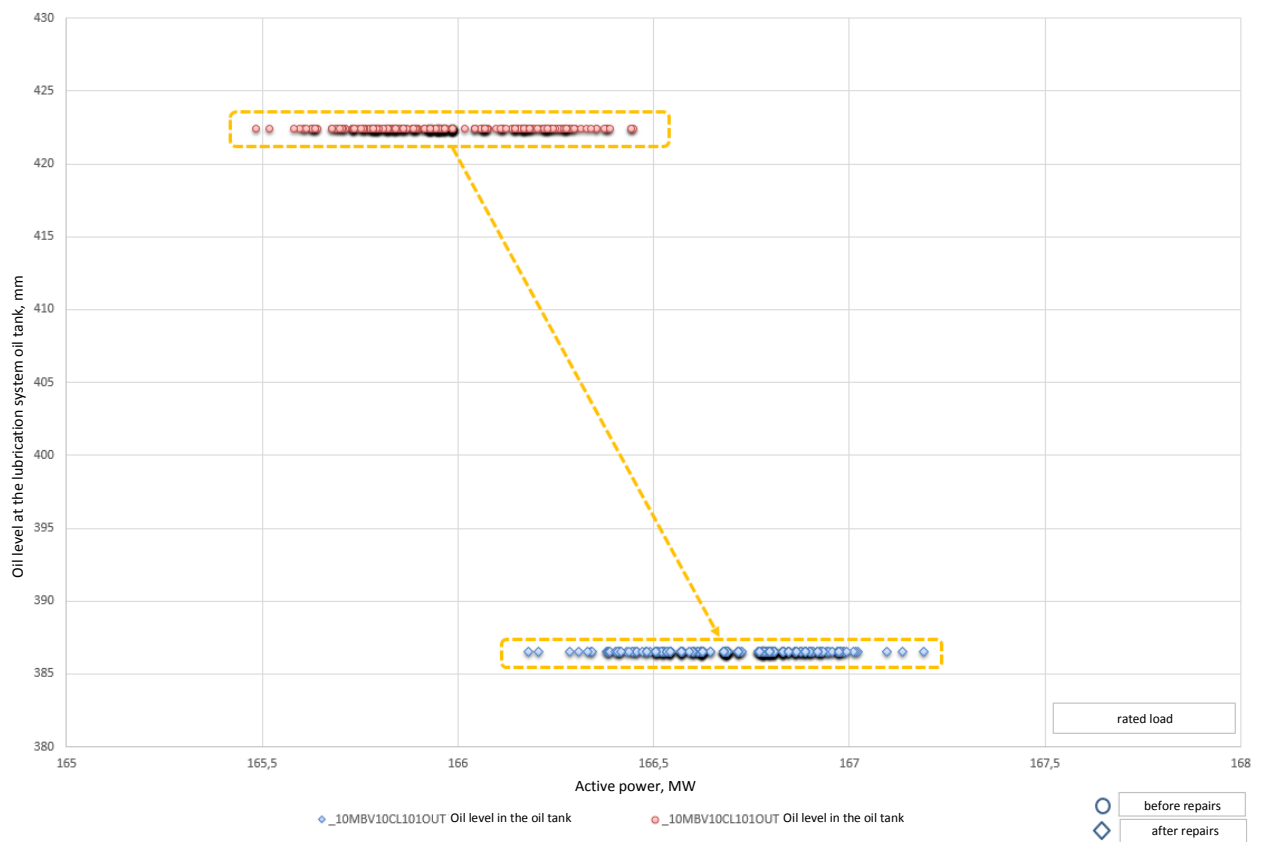
6. *There is a positive effect on level increase in the oil tank, associated with measures on re-filling the oil tank.*
7. *In order to correctly assess the technical and economic indices of GTU in particular and CCGT in general, it is recommended to retrofit a standard weather station with additional equipment for barometric pressure measuring, archiving the signals in the power unit APCS archive.*

Fig. 4.1. Oil level in the oil tank, no-load operation before/after repairs

Fig. 4.2. Oil level in the oil tank, average load mode before/after repairs

Fig. 4.3. Oil level in the oil tank, nominal load mode before/after repairs

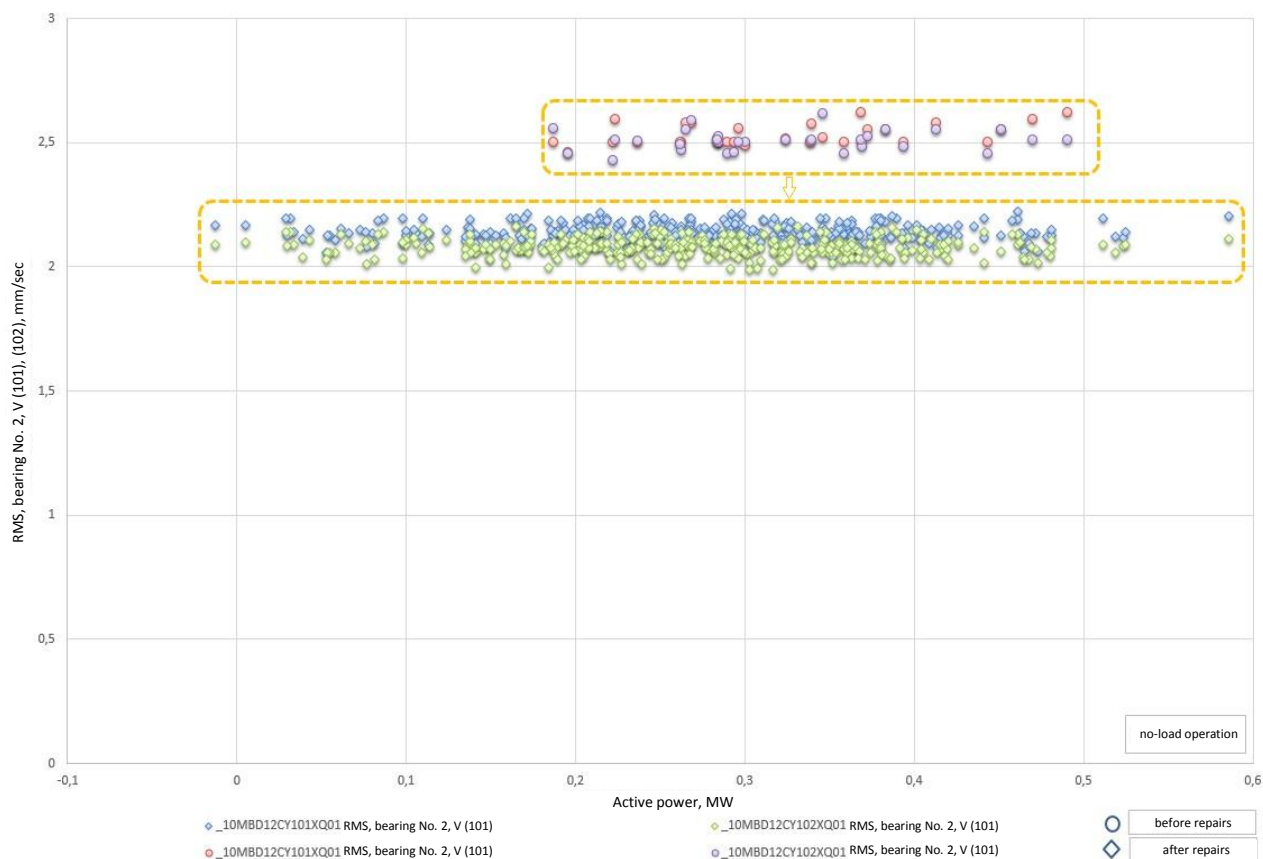
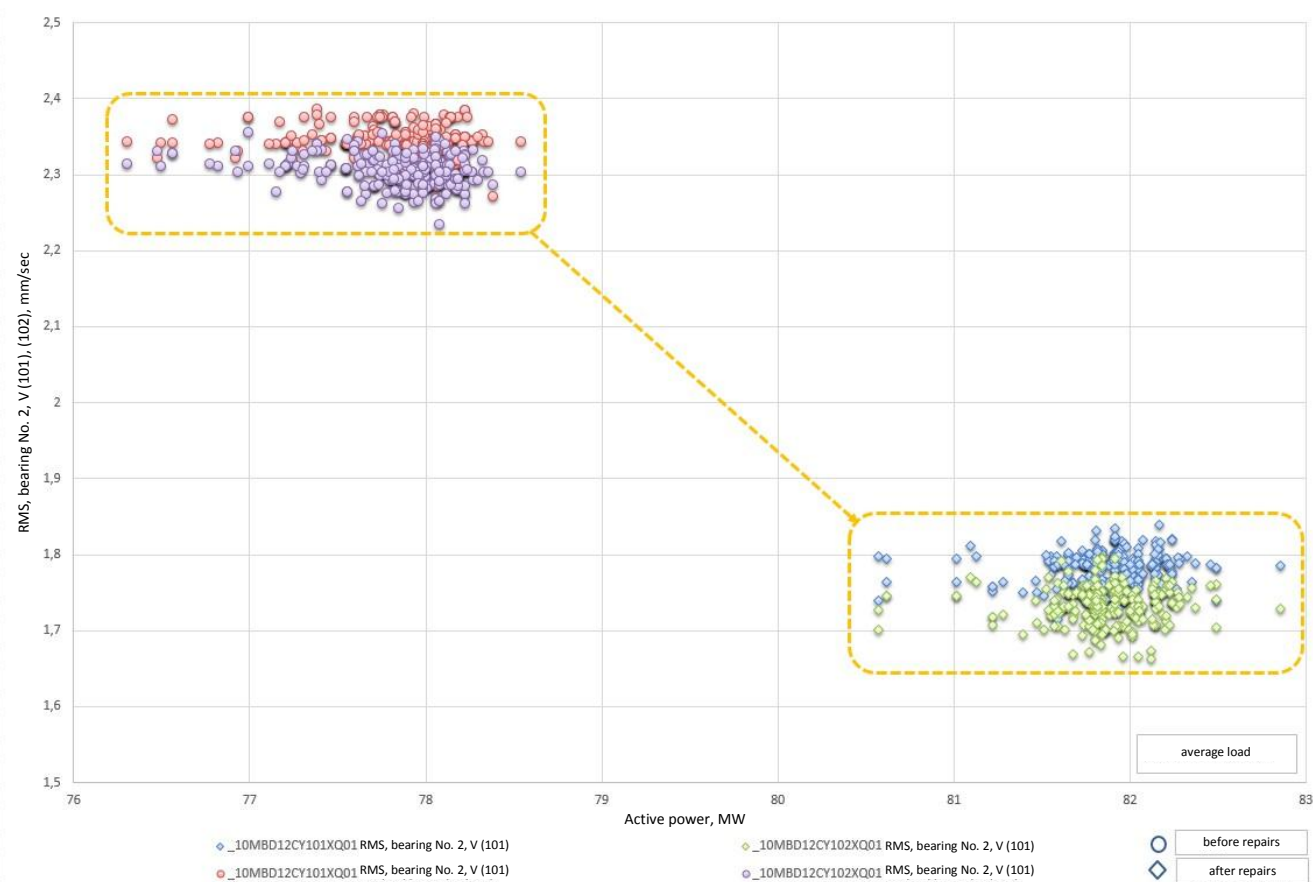
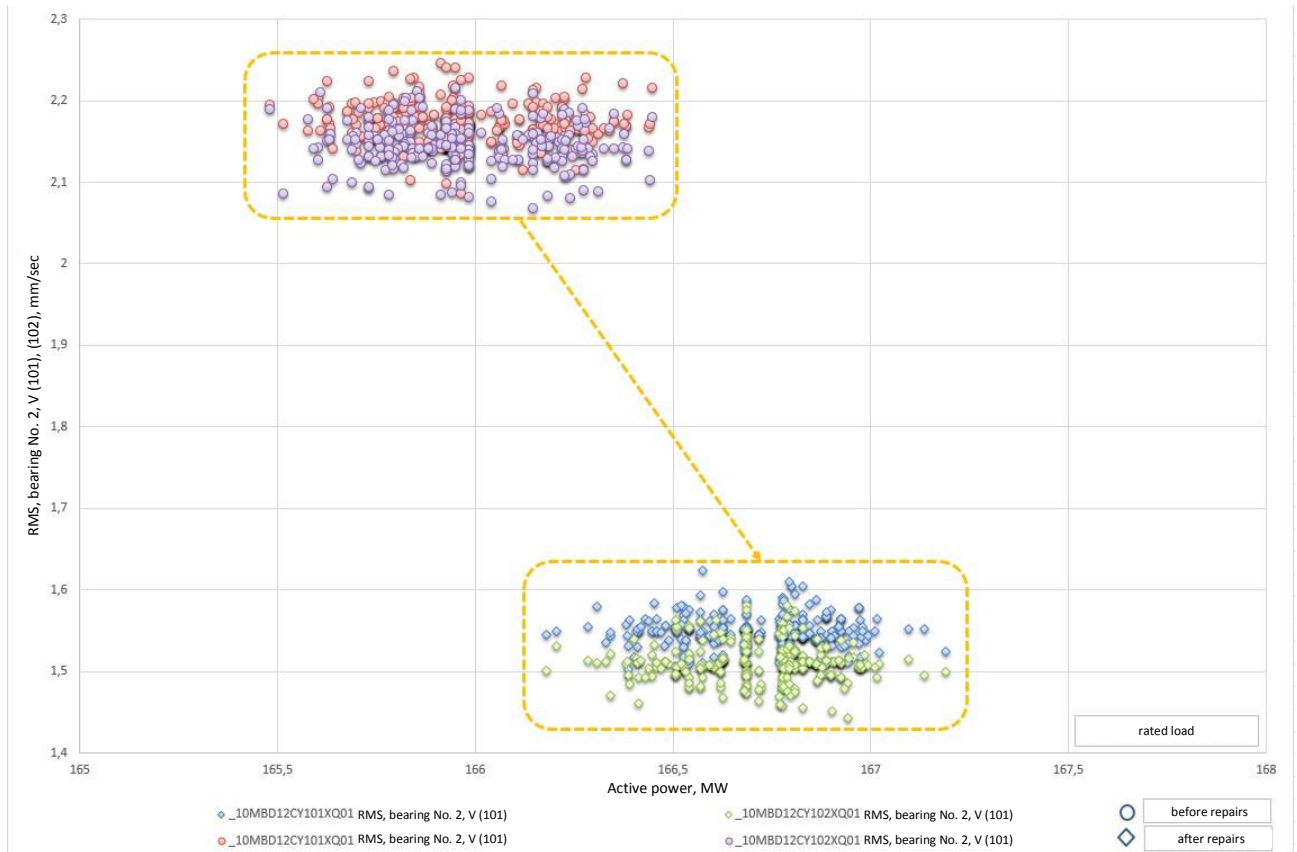
The most significant deviations are observed on the bearing No. 2 of the compressor (reduction of absolute vibration; increase in journal bearing babbit temperatures; inaccuracy of relative vibration readings). Less significant is the reduction of RMS in: the turbine bearing No. 1, generator bearings No. 3, 4, as well as reduction of shaft vibration in the generator bearing No. 3.

Fig. 5.1. RMS, bearing No. 2 (V), no-load operation before/ after repairs

Fig. 5.2. RMS, bearing No. 2 (V), average load mode before/ after repairs

Fig. 5.3. RMS, bearing No. 2 (V), nominal load mode before/ after repairs

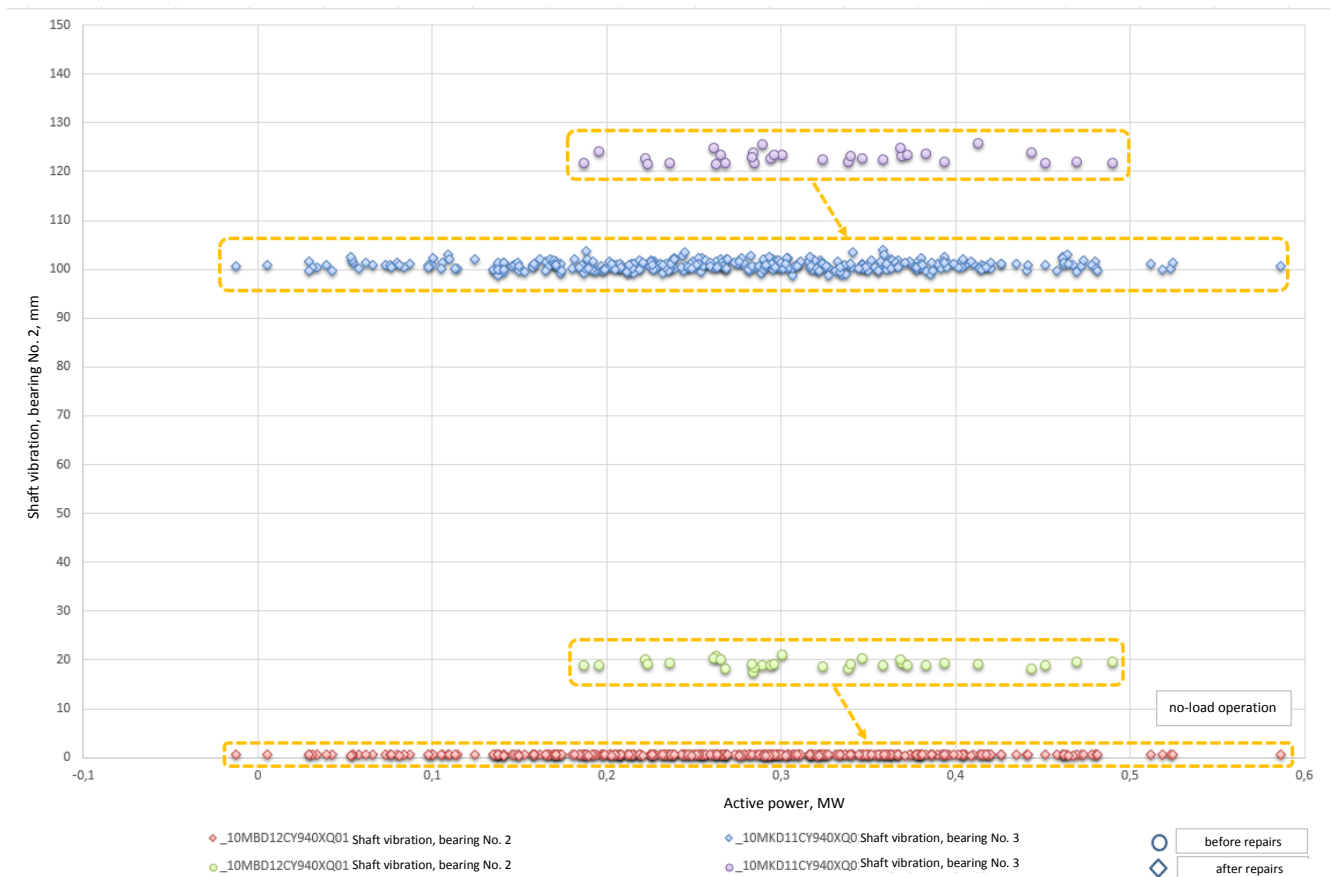
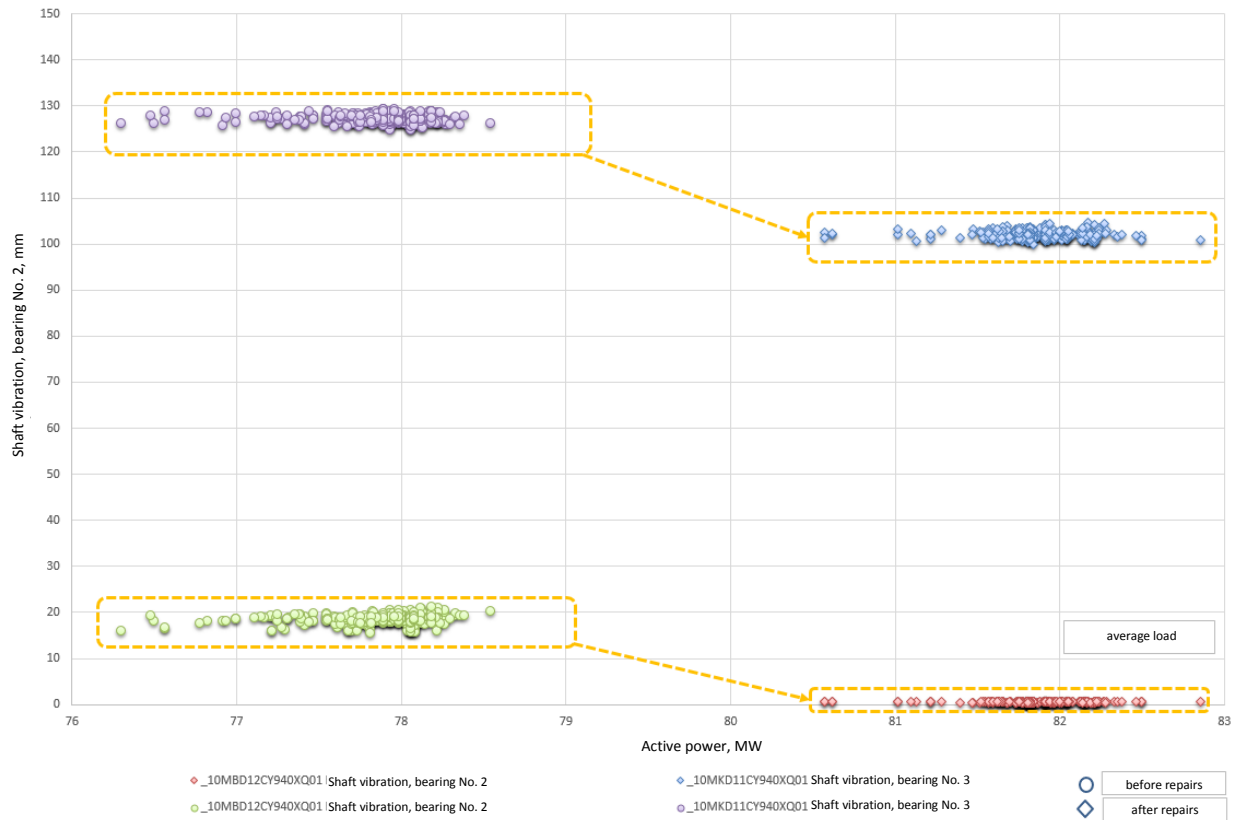
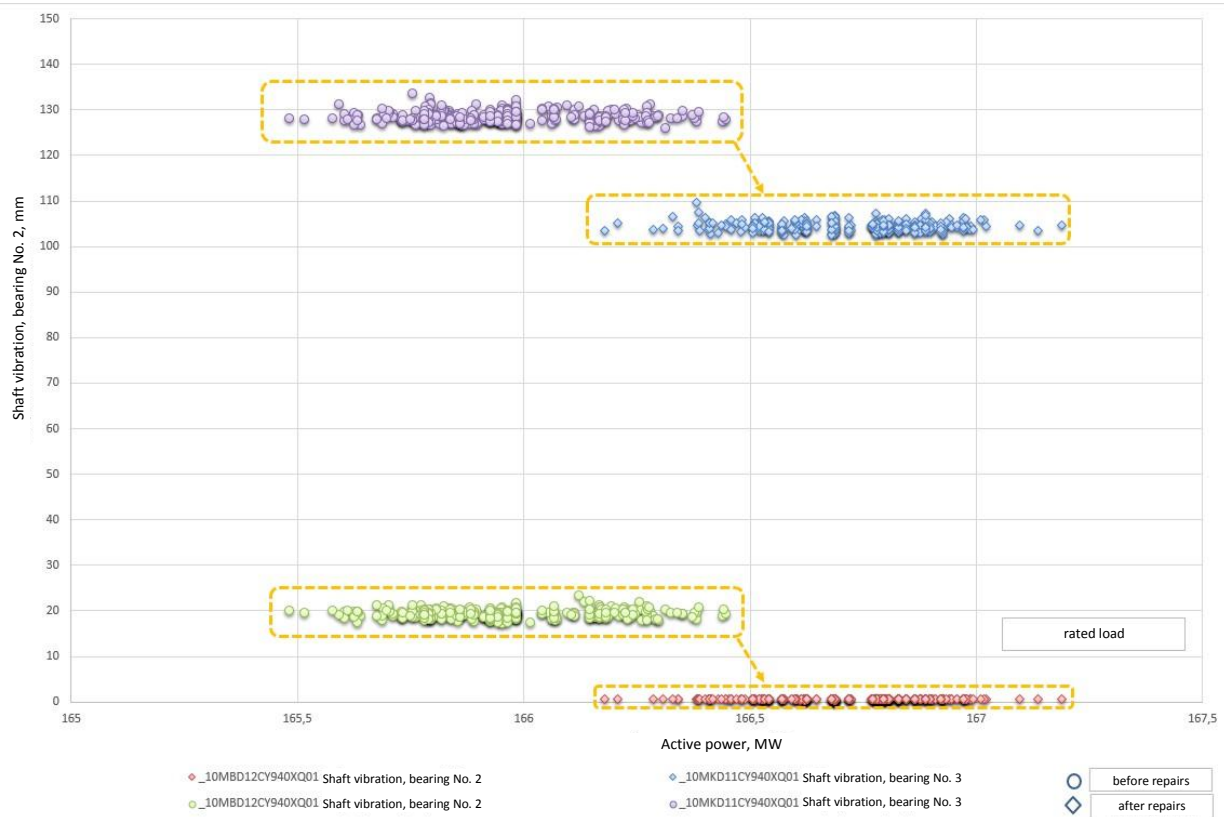
Fig. 6.1. Shaft vibration, bearing No. 2, No. 3, no-load operation before/after repairs

Fig. 6.2. Shaft vibration, bearing No. 2, No. 3, average load mode before/after repairs

Fig. 6.3 Shaft vibration, bearing No. 2, No. 3, rated load mode before/after repairs

2. *Changes in vibration parameters and bearing support temperatures correspond to the measures taken and can be evaluated as positive, with the exception of an increase in compressor journal bearing temperature and the uncertainty of readings in relative vibration of the compressor bearing. It is recommended to restore a channel measuring the compressor relative vibration.*
