Date : 21.12.2018
Company :
Branch :
Plant :
Unit : GTE-160 st. No. 2
Factory No:

Conclusion No. 02.1-R

On the impact of repairs / adjustment works on the technical condition of the unit

Date of shutdown for repairs	Repair / adjustment finish date	Repair duration, days	Reason for repairs
15.09.2018	24.10.2018	39	Conduct of a large scheduled inspection of GT after 33,000 equivalent hours of operation.

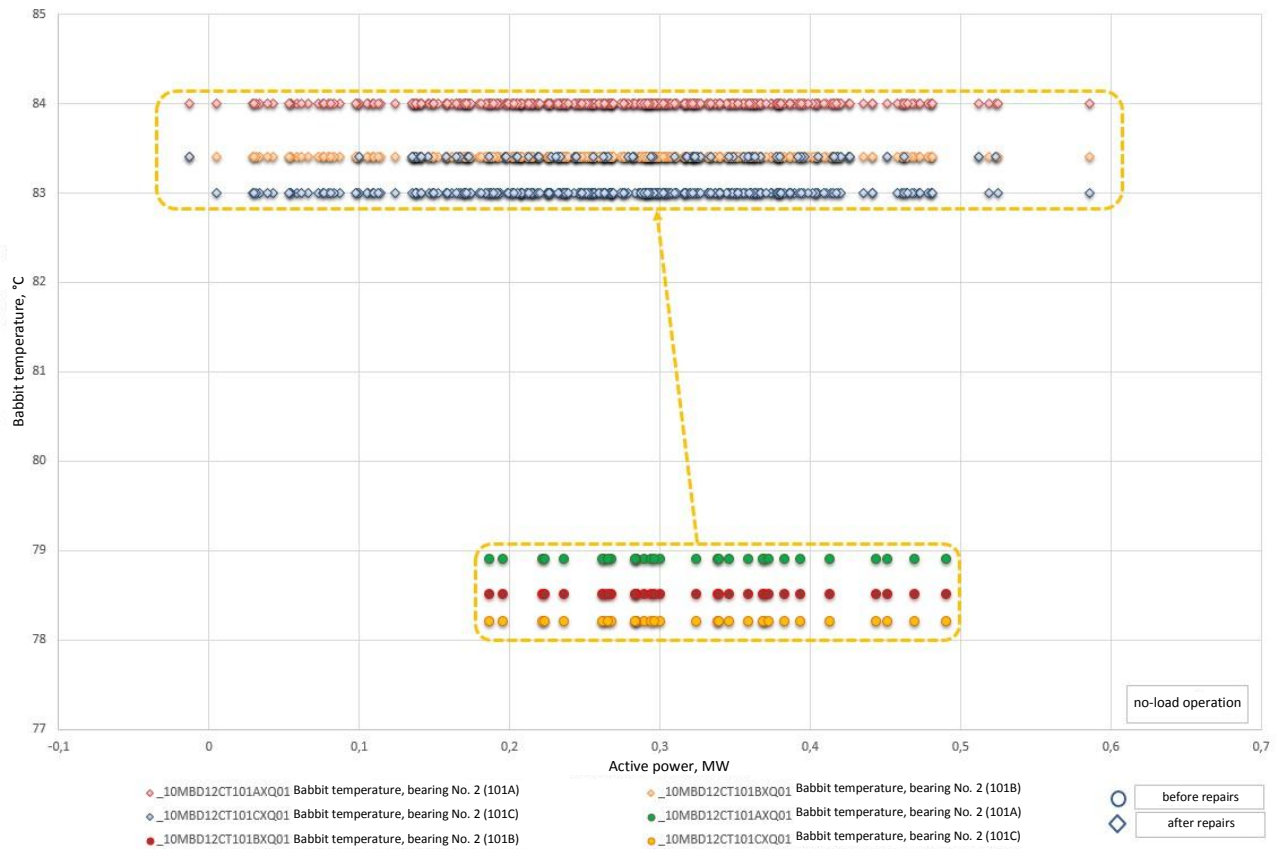
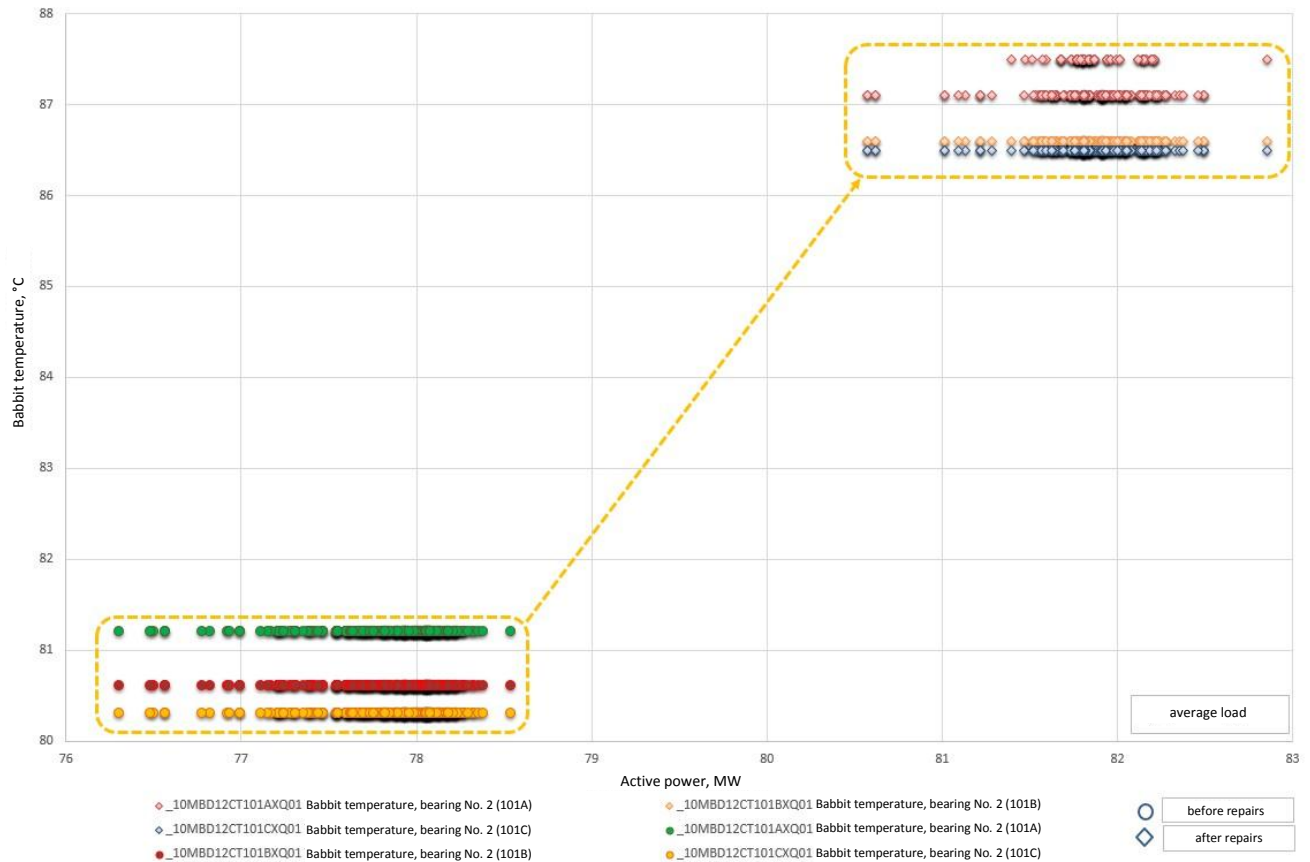
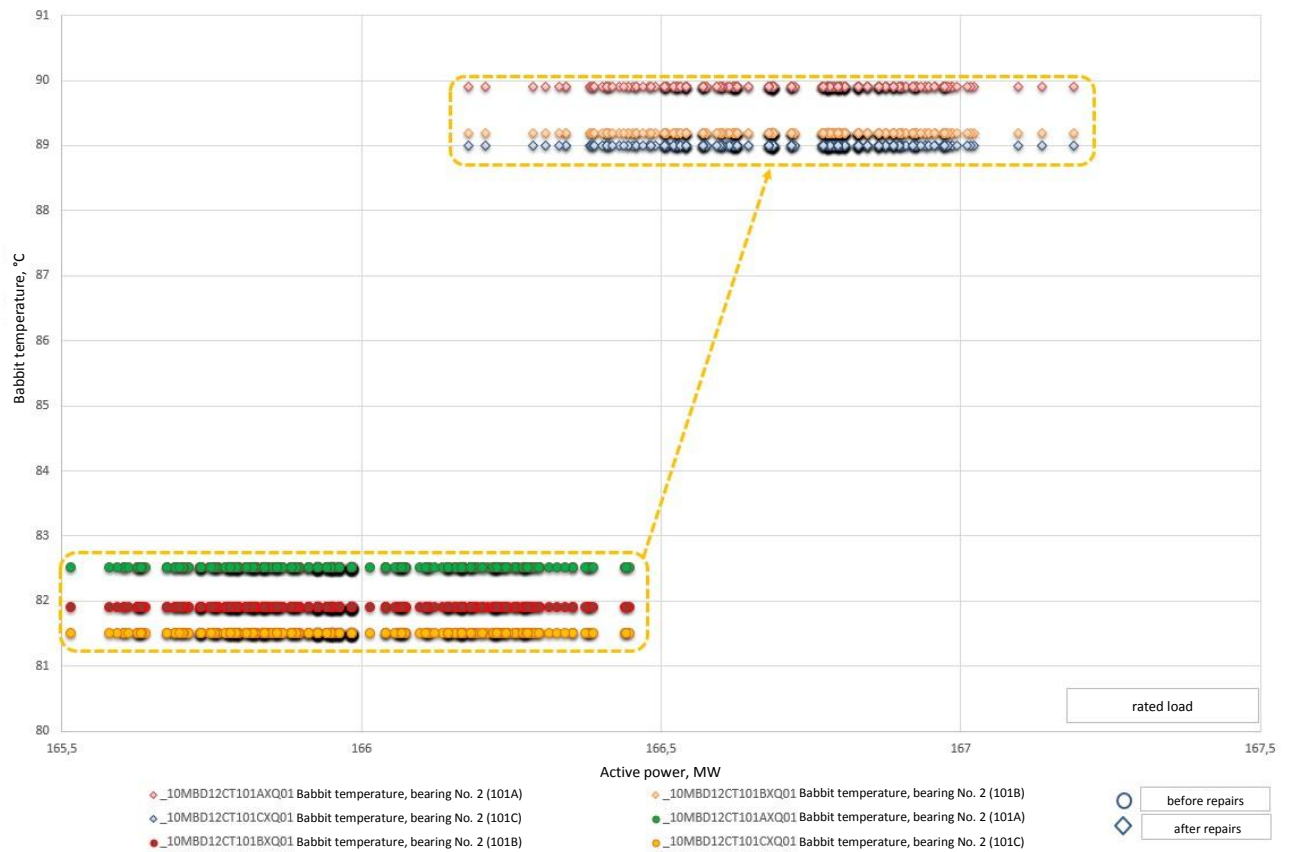
The most significant deviations are observed on the bearing No. 2 of the compressor (reduction of absolute vibration; increase in journal bearing babbit temperatures; inaccuracy of relative vibration readings). Less significant is the reduction of RMS in: the turbine bearing No. 1, generator bearings No. 3, 4, as well as reduction of shaft vibration in the generator bearing No. 3.

Fig. 7.1. Babbit temperature, bearing No. 2, no-load operation before/after repairs

Fig. 7.2. Babbit temperature, bearing No. 2, average load mode before/after repair

Fig. 7.3. Babbitt temperature, bearing No. 2, nominal load mode before/after repair

2. *Changes in vibration parameters and bearing support temperatures correspond to the measures taken and can be evaluated as positive, with the exception of an increase in compressor journal bearing temperature and the uncertainty of readings in relative vibration of the compressor bearing. It is recommended to restore a channel measuring the compressor relative vibration.*
